Beckfoot School Accessibility Action Plan April 2023 (Updated Sept 24)

4.1 - ACTION TABLE

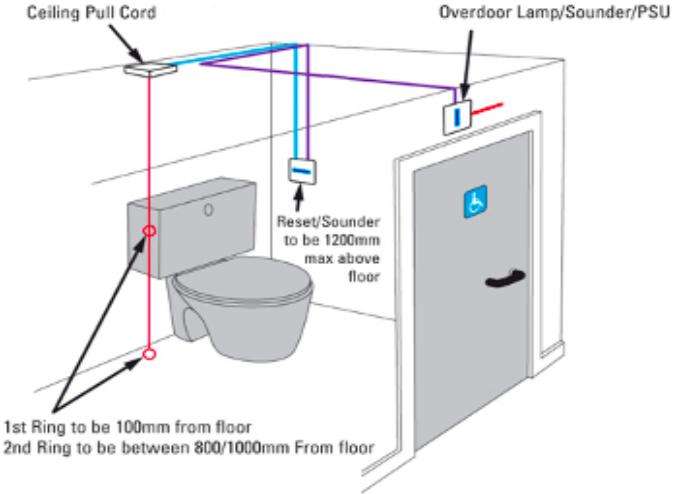
13.11	<p>Cord alarms throughout the facilities were positioned in various states.</p> <p>An alarm system was not identified in LS5; broken cord alarms were identified in WC6 and WC10; tied cord alarms were identified in WC5, WC9, WC12, WC17, WC18, Sports Block and Arts Block facilities; further alarm systems were either too short, or hanging on the floor, including in WC4, WC19, WC20 and WC3.</p> <p>Incorrectly positioned cord alarm systems could result in a distress call going unnoticed.</p>	<p>Each facility should feature a cord alarm correctly positioned. Implement a management procedure to ensure that cord alarms are always kept loose and not tied up.</p> <p>☐</p> <p>According to BS8300 - An emergency assistance pull cord should be sited so that it can be operated from the WC and from an adjacent floor area. The emergency assistance pull cord, coloured red, should be provided with two red bangles of 50 mm diameter, one set at a height between 800 mm and 1000 mm and the other set at 100 mm above floor level.</p>

M/N	All Cords are checked regularly and reported if defective for replacements.

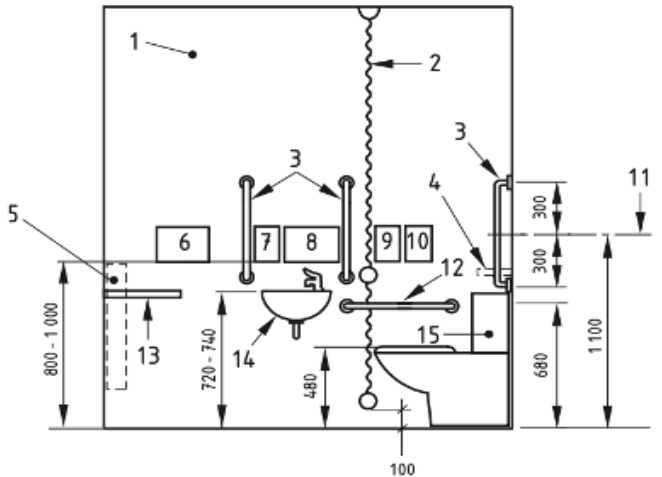
13.5	<p>High dispensers and mirrors were identified across various facilities.</p>

<p>The tissue, soap and towel dispensers should be relocated at a height of between 800mm and 1000mm above finished floor level. Refer to BS8300 Figure 42 for guidance.</p> <p>Ideally, full-length mirrors should be present at a height between 600mm - 1600mm located away from the handbasin in accordance with BS8300.</p> <p>Height of drop-down support rails to be the same as the other horizontal grab rails.</p> <p>Key</p>

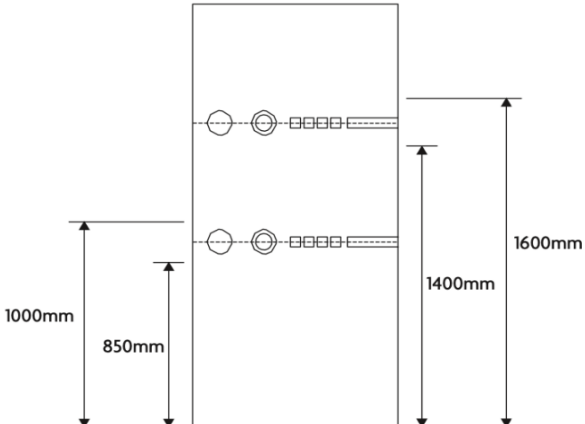
8.2	<p>The large, glazed doors leading from the library, and further exits leading from the school did not feature manifestations to assist with reducing a collision hazard. Manifestations on the large, glazed areas next to classroom doors were inconsistently positioned.</p>	<p>The glazed areas must be clearly highlighted with manifestation that contrasts visually with the surface behind it. This manifestation should be located within two zones, from 850mm to 1000mm from the floor and from 1400mm to 1600mm from the floor.</p>

<p>Manifestation can take various forms, e.g. broken or solid lines, patterns or company logos</p>	M

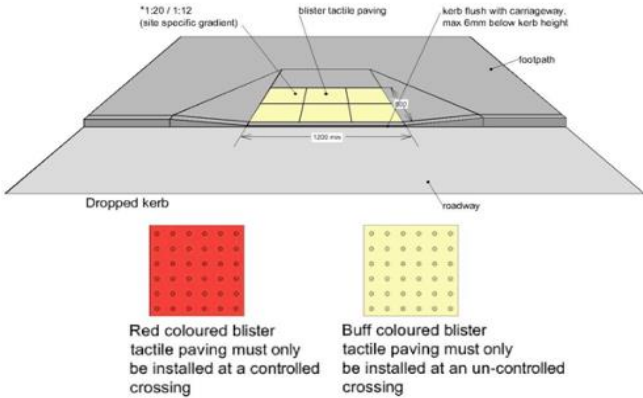
1.2	<p>Crossing points on approach to the school featured dropped kerbs and tactile paving.</p> <p>The crossing point next to the car gates and intercom systems featured slightly damaged tactile paving, which could cause confusion for people who are partially sighted.</p> <p>The crossing next to the main, school gates was faded and requires remarking.</p>	<p>Site management to schedule repair of the tactile paving to replace the broken areas.</p> <p>The crossing point requires remarking to ensure that it is clearly distinguishable.</p>

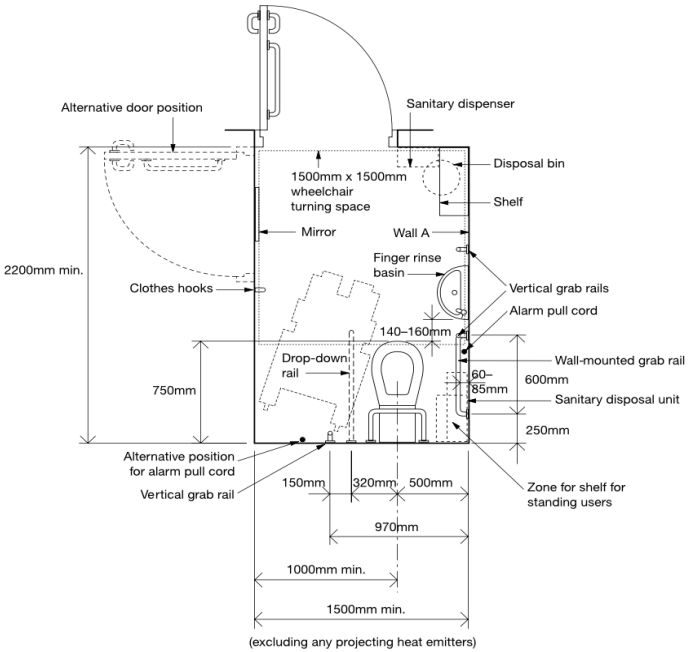
13.1	<p>A number of accessible WC facilities were provided across the school, including in hygiene rooms. Measurements are as follows:</p> <p>Hygiene room LS5 was suitably sized; WC4 1970mm by 2530mm; WC6 3300mm by 1700mm; WC5 1885mm by 3300mm; WC7 1500mm by 2880mm; WC10 2250mm by 1630mm; WC9 1500mm by 2630mm; WC12 2045mm by 2200mm; WC19 1460mm by 2290mm; WC20 2275mm by 1470mm; WC17 2520mm by 1560mm; WC18 2530mm by 2180mm; WC16 2310mm by 1580mm; WC15 2700mm by 1490mm; WC3 2440mm by 1555mm; WC4 Art Block 2180mm by 1500mm; WC22 Art Block 2218mm by 1500mm.</p>	<p>During future developments and proportionate to demand, the architectural feasibility of increasing the size of the accessible WCs that fall within the minimum ADM standards should be considered.</p>

<p>Note Layout for right-hand transfer to WC</p>	M/ST

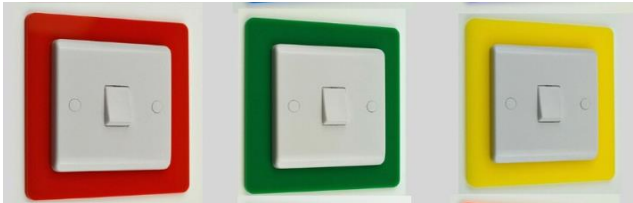
16.2	<p>A combination of backgrounds were provided to the light switch plates. The white switch plates positioned against light backgrounds, may not provide sufficient contrast to assist people who are partially sighted.</p>

<p>At the next refurbishment for the sites, it would be beneficial to change the existing light switch plates with alternatives that have a grey/silver plate. This will ensure that they are easily located by people with impaired vision.</p> <p>All switches that require precise hand movement, such as light switches, thermostats etc, should be located between 750mm – 1200mm from floor level.</p>	M
