Beckfoot School Accessibility Action Plan April 2023

4.1 - ACTION TABLE

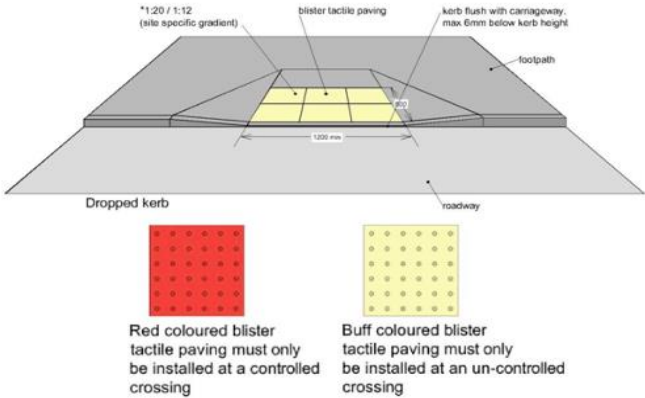
<p>1.2</p>	<p>Crossing points on approach to the school featured dropped kerbs and tactile paving.</p> <p>The crossing point next to the car gates and intercom systems featured slightly damaged tactile paving, which could cause confusion for people who are partially sighted.</p> <p>The crossing next to the main, school gates was faded and requires remarking.</p>	<p>Site management to schedule repair of the tactile paving to replace the broken areas.</p> <p>The crossing point requires remarking to ensure that it is clearly distinguishable.</p>
